REPORT OF INVESTIGATION

Underground Metal Mine
(Copper)

Fatal Fall of Ground Accident
July 30, 2007

Genesis Inc., Troy Mine
Genesis Inc.
Troy, Lincoln County, Montana
Mine I.D. No. 24-01467

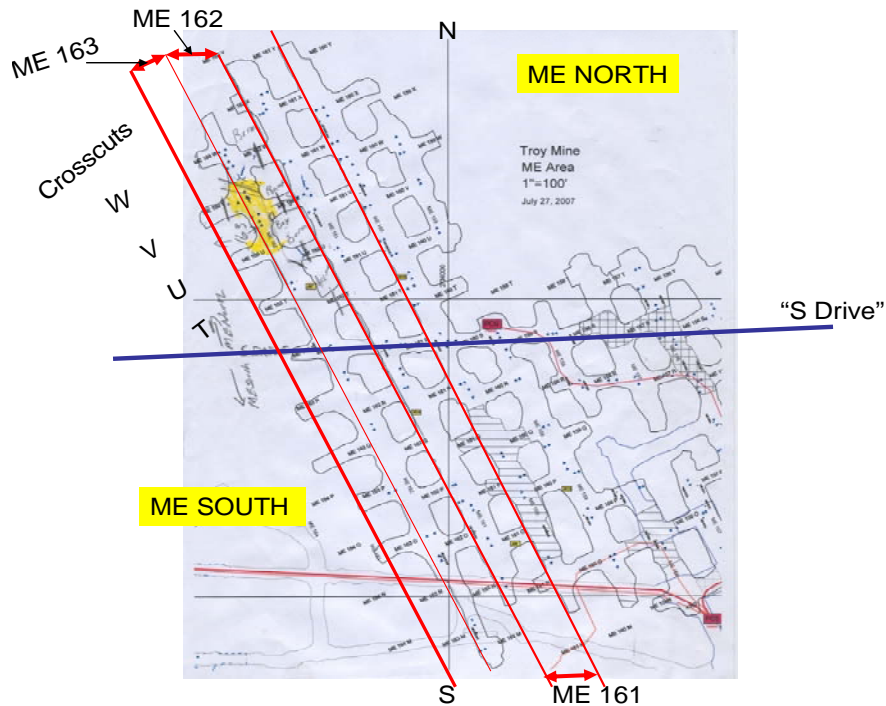
Figure 1

Each crosscut was designated in an ascending alphabetical order going north with the drifts identified numerically in descending order away from the 165 fault zone. The west pillar rib line of each drift started the next sequential numbering. The fall of ground occurred in the ME 163 V crosscut at the intersection with the ME 162 drift (Figure 1).

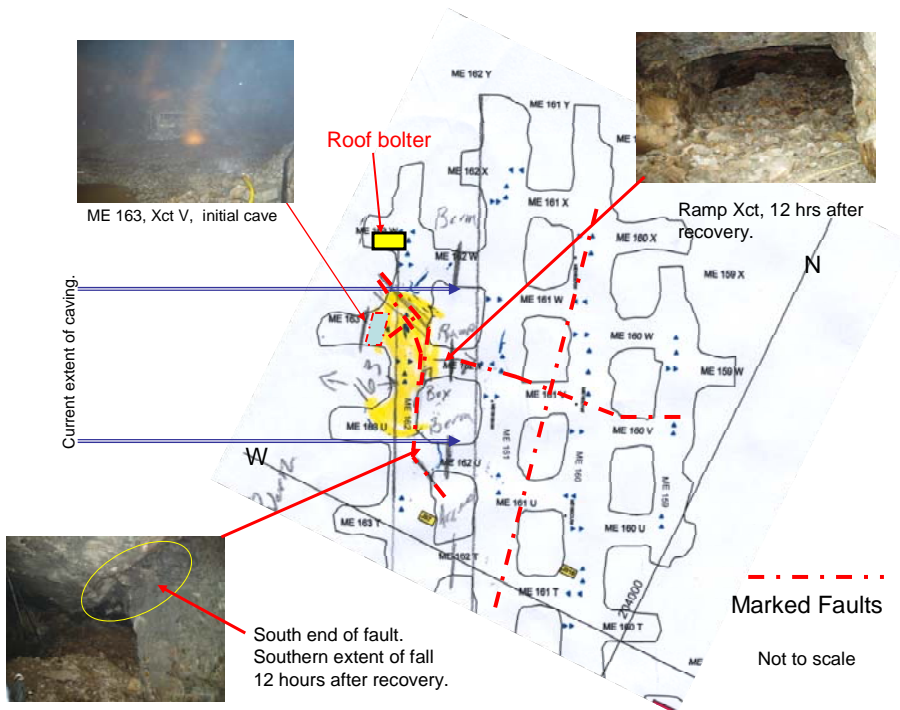
Figure 2

The initial fall of ground occurred at a fault zone in the ME 163 at the V crosscut (Figure 2). The fault zone had been encountered in the ME 162 drift between the ME 162T and ME 162U crosscuts. The ME 162 drift was advanced with the fault zone exposed in the back for a distance of approximately 200 feet. The crosscut was advanced westward to the 165 fault contact zone as were all the previous ME 163 crosscuts. Management indicated that ground conditions had been very difficult after encountering the fault zone. Ground water was observed flowing from several joints in the section and a brown stain was noted on fallen material. Difficulties were encountered supporting the back due to stability problems with jointing and spans. To stabilize the fractured back between the Swellex bolts in this fault zone, welded wire mesh was bolted to the back and shotcrete was applied. The shotcrete constituted a thin surface coating that was ineffective for ground stabilization. Management indicated that the fault zone was so problematic that the next pillar (bounded by the ME 162U and ME 162V crosscuts) had not been reduced by secondary mining in an attempt to leave rock to support the fault zone. Mine maps provided by management indicated that the fault zone continued along the ME 162 drift beyond this pillar but the next pillar was reduced in size by secondary mining to extract ore.

The utility truck the victim was operating was parked directly underneath the fault zone where it projected across the mouth of the ME 163V crosscut in the ME 162 drift. Despite recognizing the fault as difficult to control, additional ground support had not been utilized and the ME 162 drift had not been barricaded.

After the ground fall, rock fragments ranged in size and were defined by smoother, more regular surfaces indicative of naturally occurring geologic structures. The host quartzite was cut by abundant parallel joint planes spaced 3-10 inches apart, defining a texture of stacked cubes in the back and ribs throughout the ME section. The material that originally fell was estimated at 700 tons.

The initial material removed during recovery placed the break above the anchor point of the 8-foot Swellex bolts. The day after the fall, it had extended south approximately 110 feet, north 70 feet, and across the span of the ME 162 entry to the east pillar line. The apex of the fall could not be accurately calculated from the toe of the fall because the distance exceeded the maximum range of the laser range finder. The fall was estimated to be more than 30 feet above the original roof and the fallen material, after the recovery, was estimated at 3,000 tons.

Corrective Action: Management should design and implement a ground support system for the entire mine that controls the ground where persons work or travel. Machinery and materials to provide additional ground support should be readily available underground when ground conditions require their use. Miners should be trained to install additional support when necessary in adverse conditions.

Corrective Action: Management should establish procedures to ensure ground examinations are conducted and adverse ground conditions are taken down or adequately supported. Persons conducting the examinations should be trained to recognize and eliminate hazardous ground conditions.
